Report No:	SZ09142021004
Date:	2021/09/14
Page:	1/26

Project Inspection Report

Company : NA
Address : NA
Sample Name : TPS62160DSGR
Manufacture : TI
Date Code : 2105
Package Type : WSON8
Sample Number : 2000 PCS
Check Number : 3 PCS
Date of Received : 09/01/2021
Date of Tested : 14:00/09/02/2021 ~ 18:00/09/06/2021

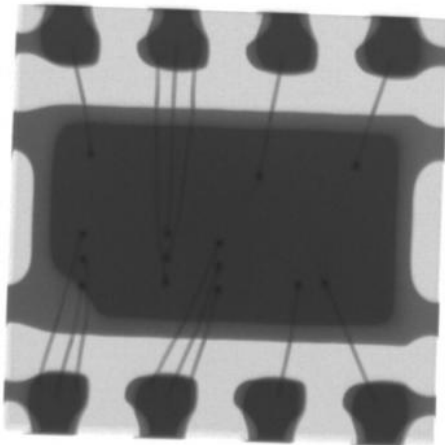
#1-Top View-All

X-ray Inspection on 3 PCS (#1-#3) samples marked with D/C2105 . No structure or bonding wire abnormal was found.

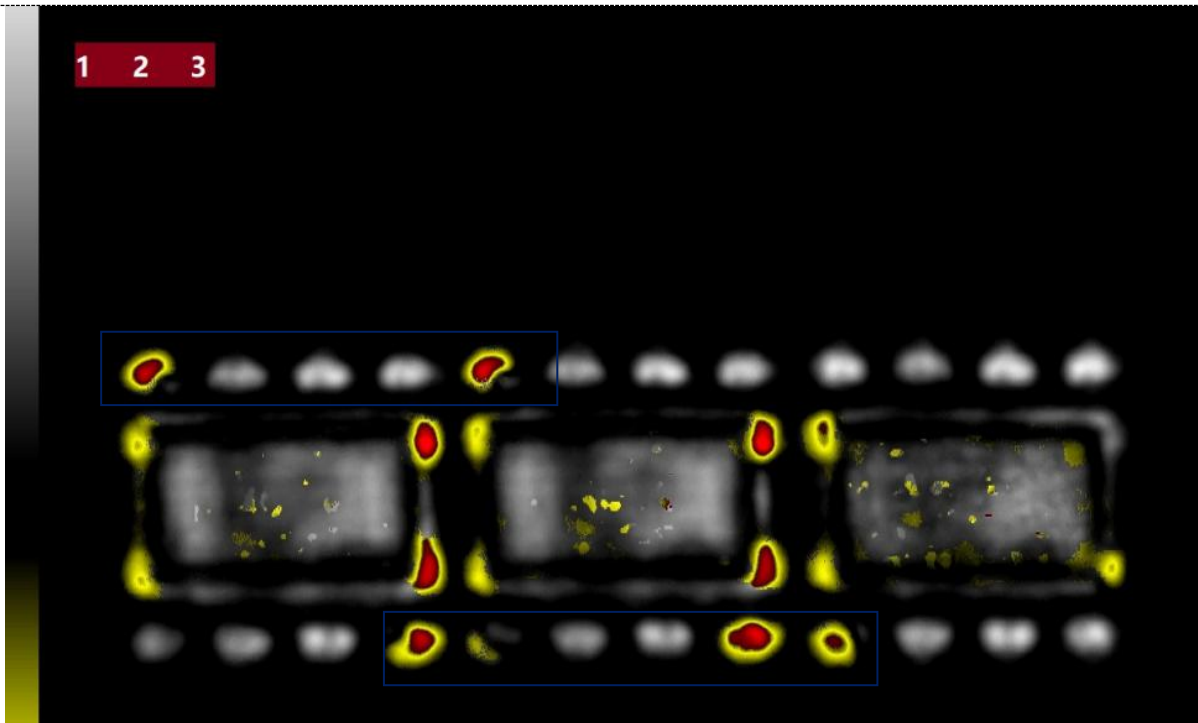
IC(#1-#3)-50MHz-Lead-C(layered)

Ultrasonic scanning microscope Inspection on 3 PCS(#1-#3) samples marked with D/C2105. The Lead of #1-#3 is layered with the bonding surface of plastic sealing material, the Paddle of #1-#3 is layered with the bonding surface of plastic sealing material.

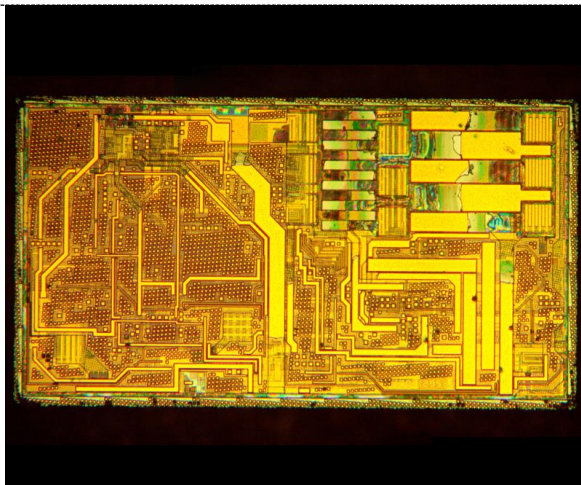
Die Topography

Internal Visual Inspection was verified on 1PCS sample. Manufacturer TI marking was found on the die surface. Die TPS62160D1 was also found on the die surface. Device confirmed to be a TI device.
