Chuangxin Online Test Center Laboratory

Project Inspection Report

Company : NA.
Address : NA
Sample Name : DRV8850RGYR
Manufacture : TI
Date Code : 20+
Package : QFN-24
Sample Number : 3 PCS
Check Number : 1 PCS
Date of Received : 05/17/2021
Date of Tested : 10:30/05/17/2021 ~ 12:00/05/17/2021

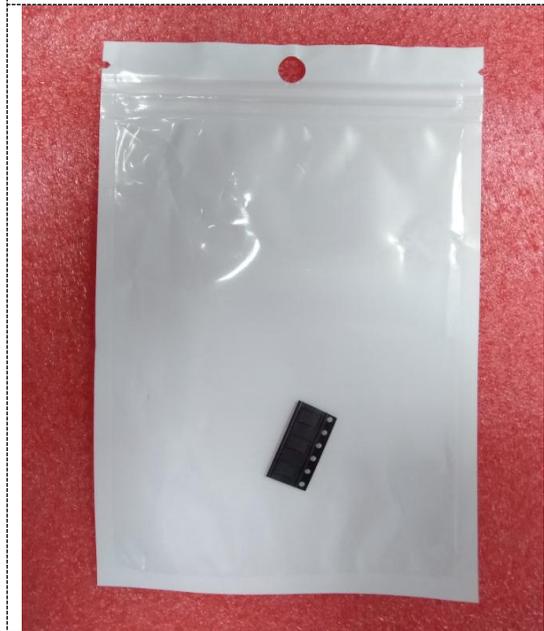
Received View

Gross Weight:	3g	Parts Total	3PCS
Number Of Boxes	N/A	intact label	N/A
Package type	Reel	Moisture protection	Non Present
MSL	N/A	ESD protection	Non Present

Note: All devices contain the same lot code 20+ (A1-A3).

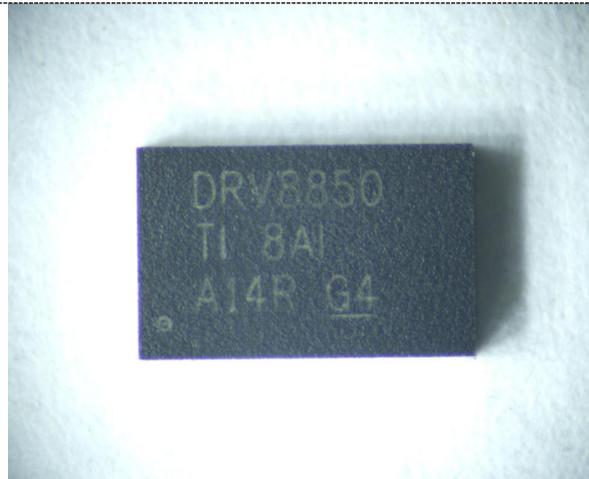
A1-Top

Internal Visual Inspection was verified on (A1) sample. Manufacturer TI marking were found with 2013 copyright year. Die marking 8850A0A0A0 were found on the die surface. Device confirmed to be a TI device.
